Appraisal and Repair of Timber Structures

Second edition

Andrew Lawrence and Peter Ross

Arup

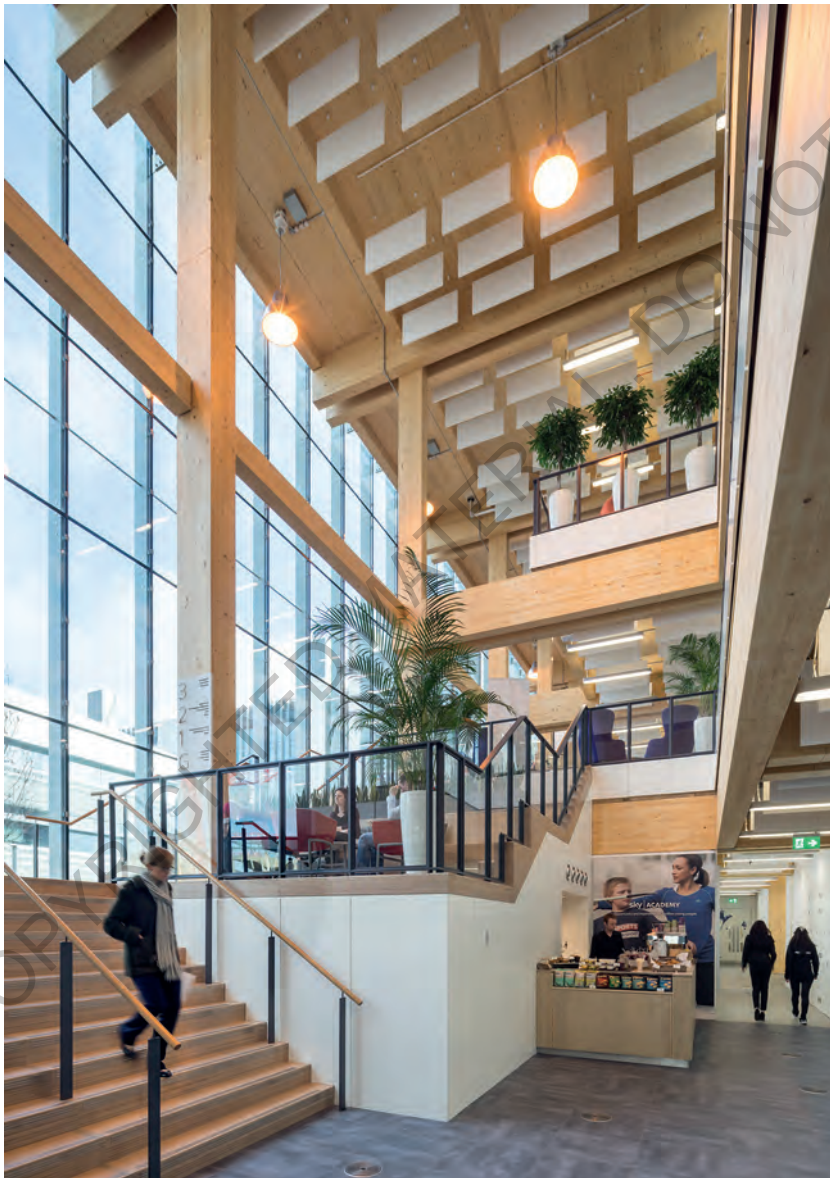
Sky Believe in Better Building (Arup Associates, 2014). The tallest all-timber commercial office building in the UK. Comprising CLT floor slabs on a glulam frame, the building was completed in less than a year and demonstrated the programme savings that could be achieved with an entirely dry prefabricated form of construction. The lower acoustic and less onerous fire requirements (compared with a residential building) enabled much of the timber to be left internally exposed, adding to the programme savings
